NASA CONTRACTOR  
REPORT

HYDROGEN ENVIRONMENT  
EMBRITTLMENT OF METALS

ROCKETDYNE

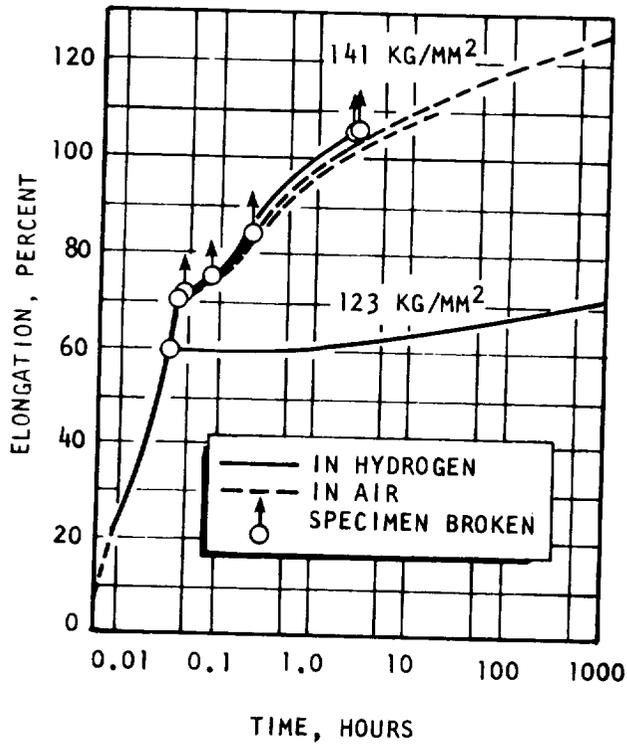
Figure 31. Creep of reinforcing steel at 104° F (40° C) in air and in 1470-psia hydrogen.

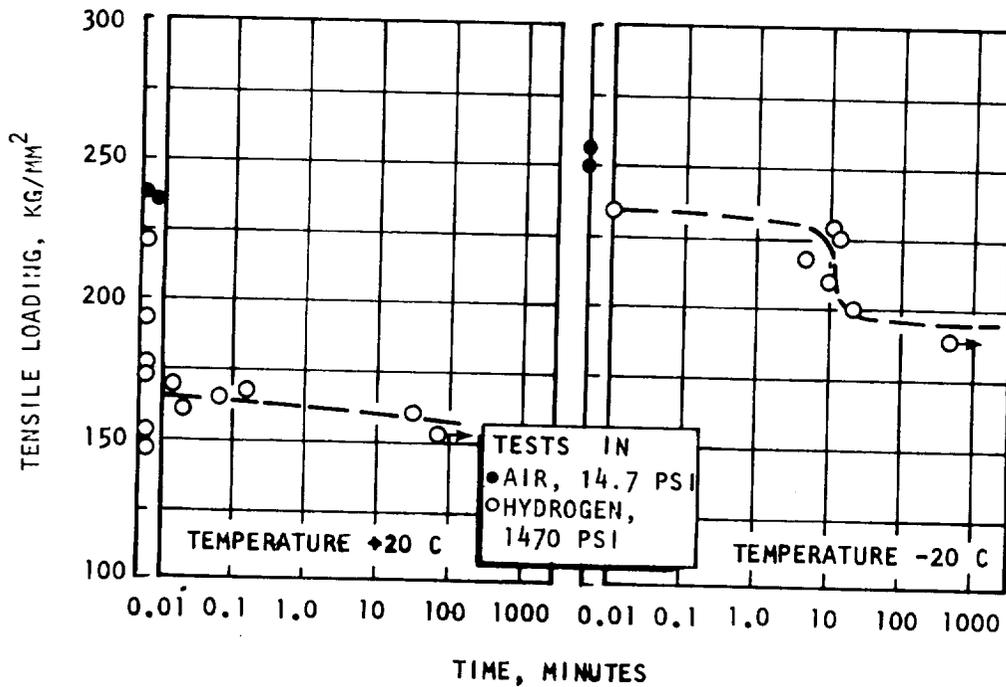
Figure 32. Creep of reinforcing steel with round notch in 1470-psia hydrogen at 68° F (20° C), and -4° F (-20° C). Tensile properties in air are shown for comparison.

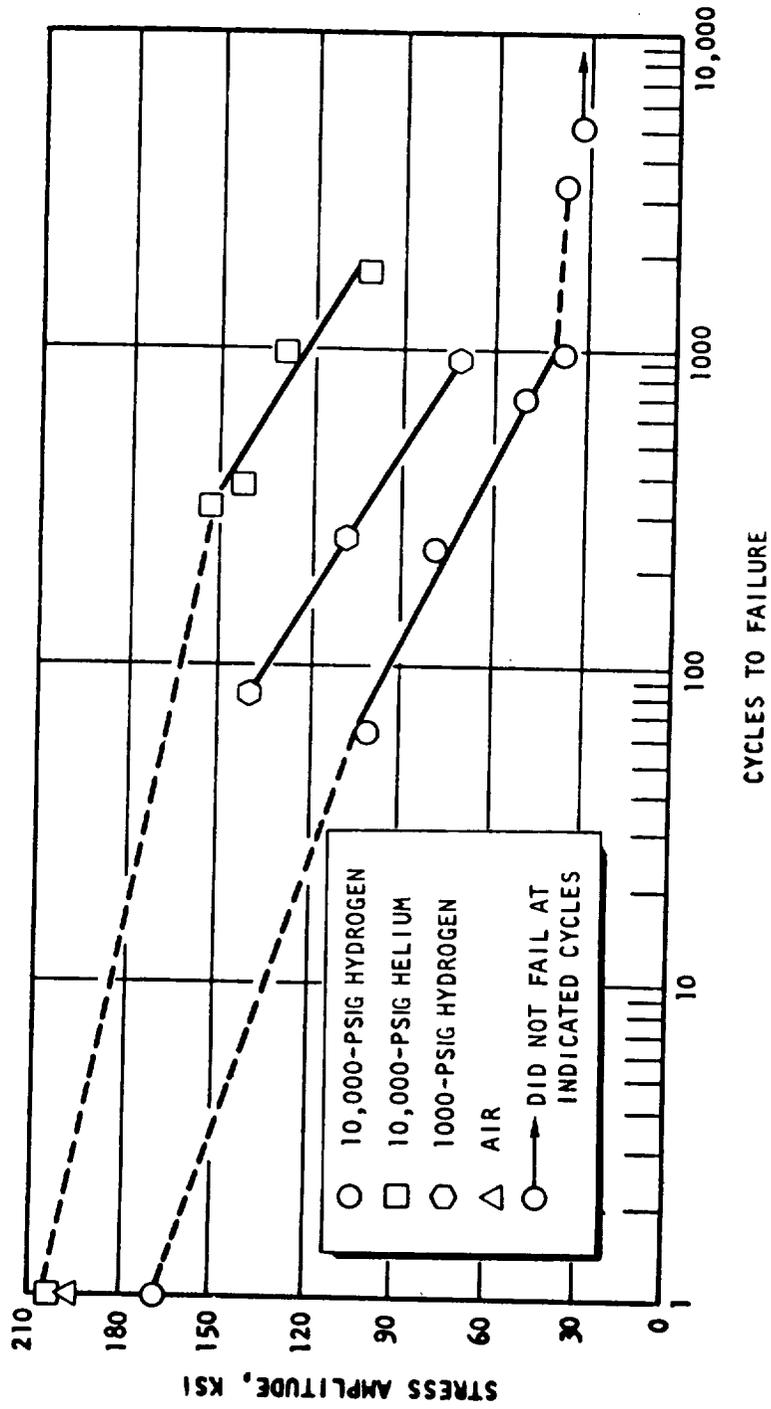
Figure 33. Effect of high-pressure hydrogen environment on low-cycle fatigue strength of precracked ASTM A533-B steel specimens. Stress was calculated using diameter after specimen was precracked (ref. 7).

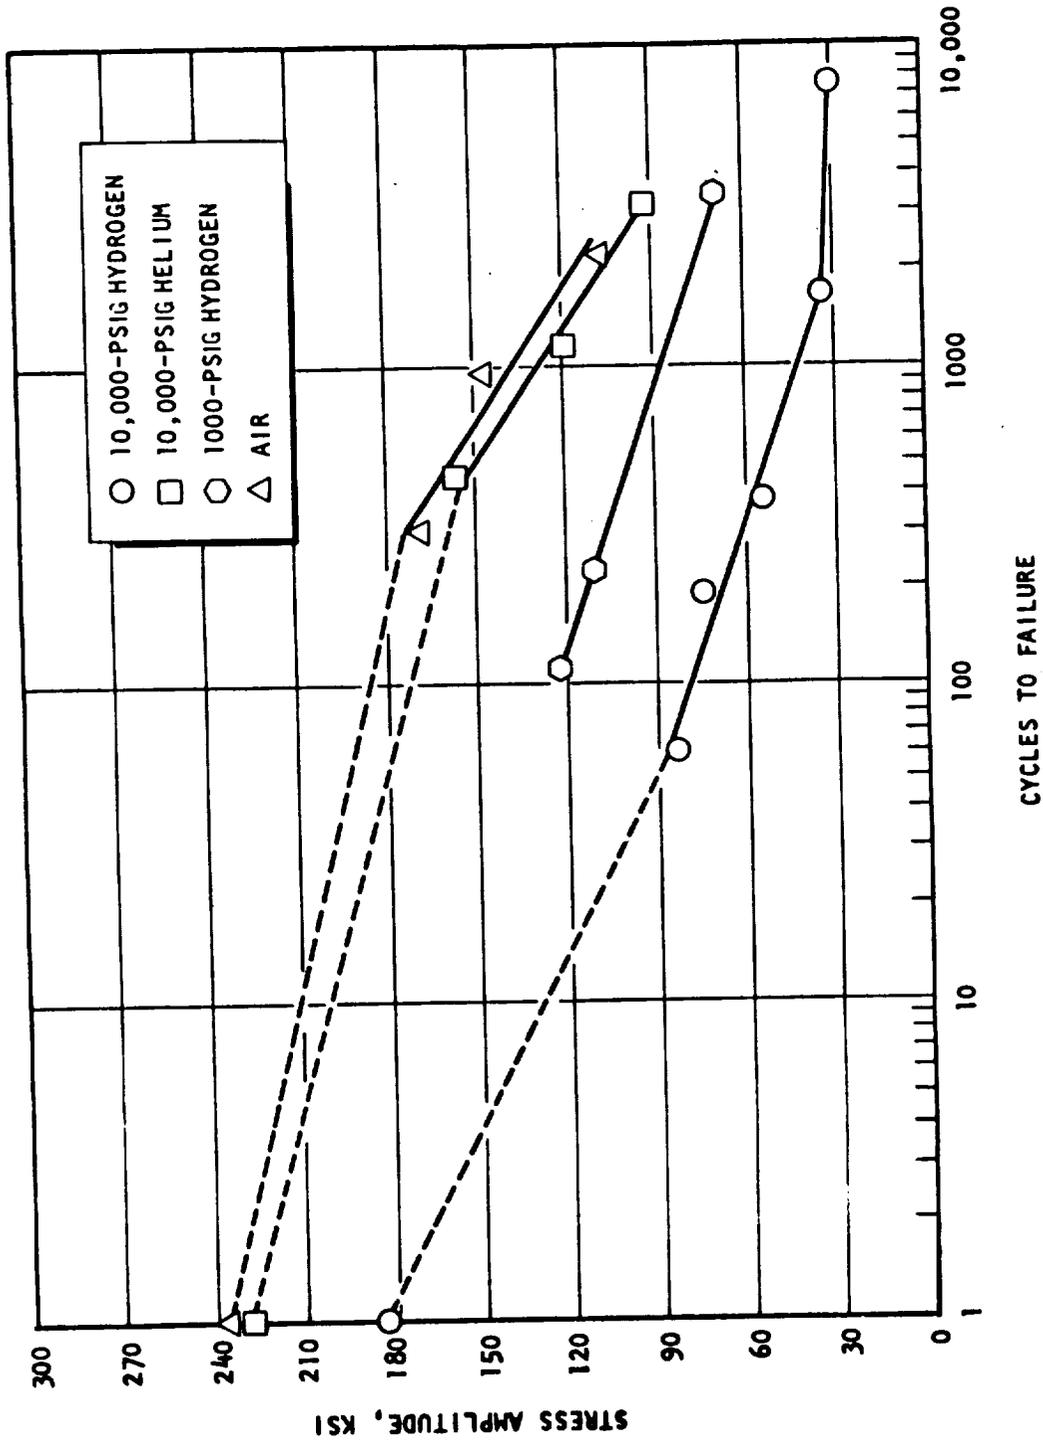
Figure 34. Effect of high-pressure hydrogen environment on low-cycle fatigue strength of precracked ASTM A-517 specimens. Stress was calculated using diameter of notched specimen prior to precracking (ref. 7).

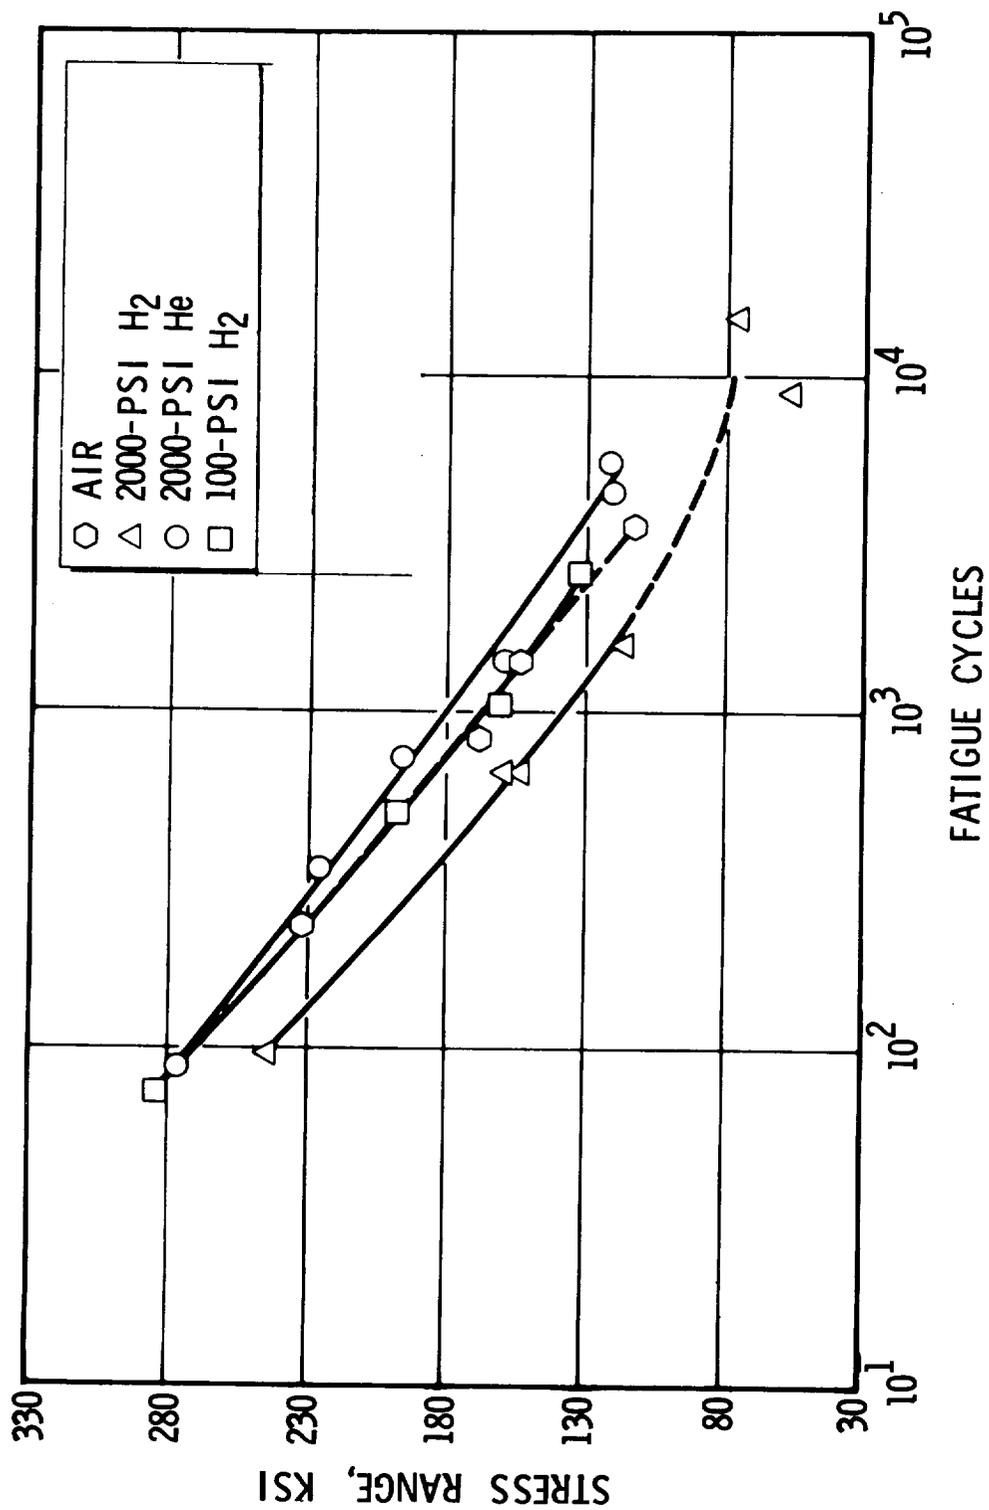
Figure 35. Effect of various environments on the low-cycle fatigue strength of precracked specimens of Inconel 718 (heat B, heat treatment 3) at room temperature. (See tables IX and X for heat and heat treatment.)

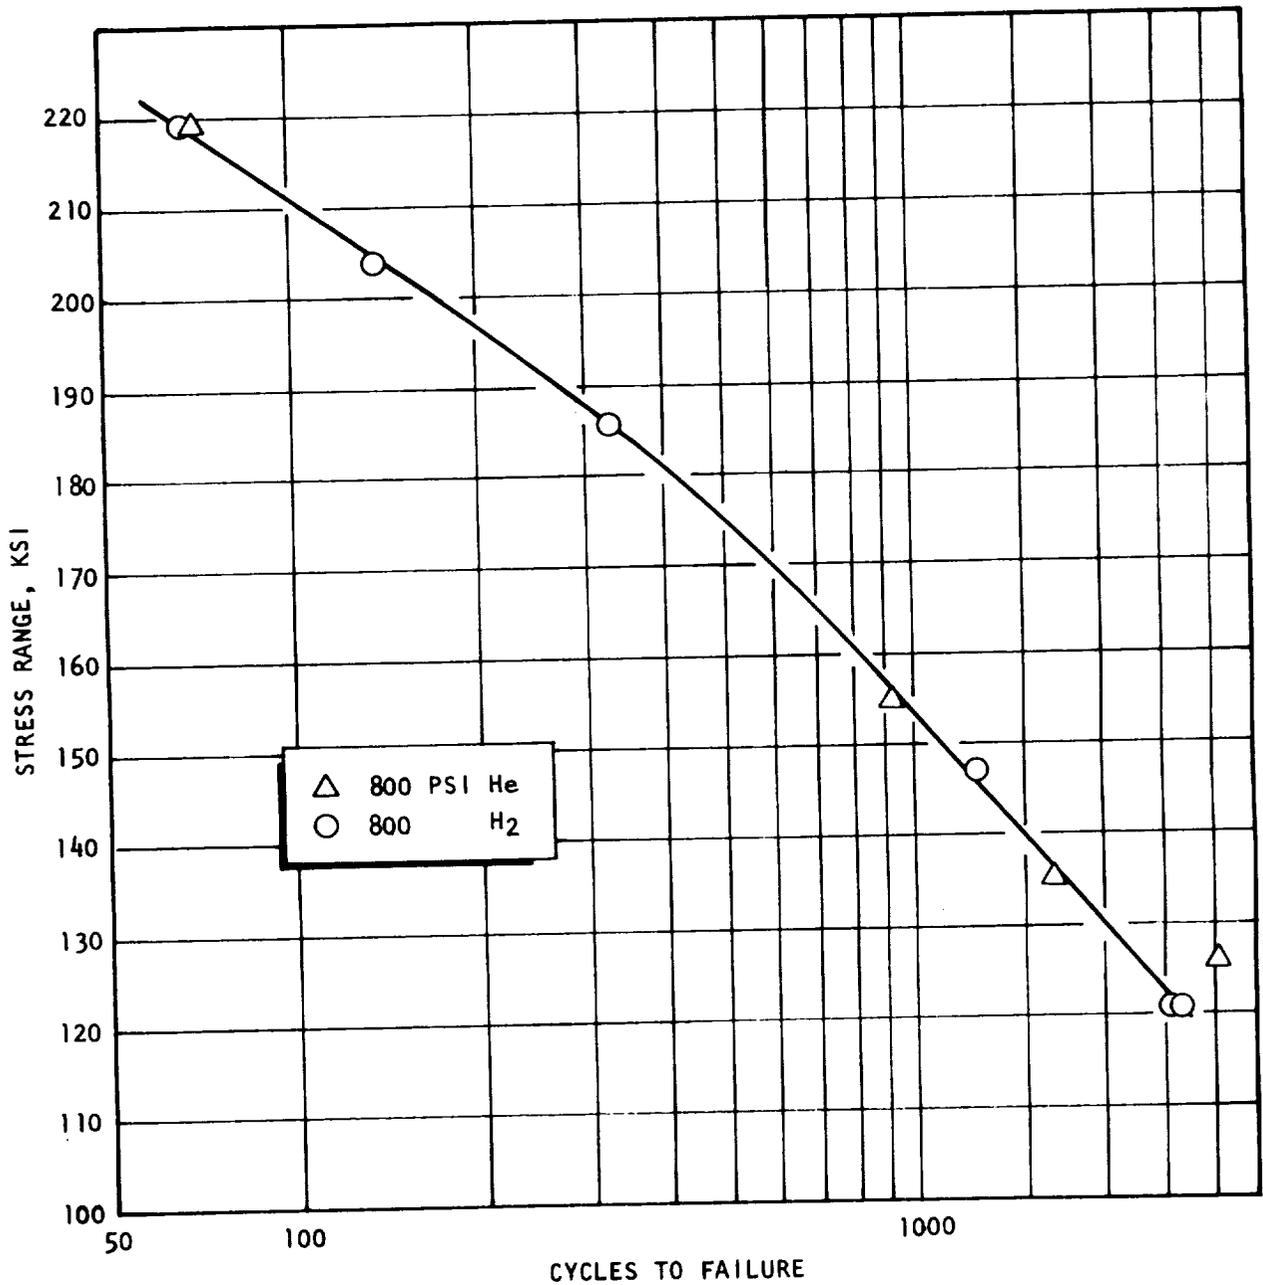
Figure 36. Effect of 800-psi hydrogen and helium on the low-cycle fatigue strength of precracked specimens of Inconel-718 (heat B, heat treatment 1) at  $-260^{\circ}$  F. (See Tables IX and X for heat and heat treatment.)

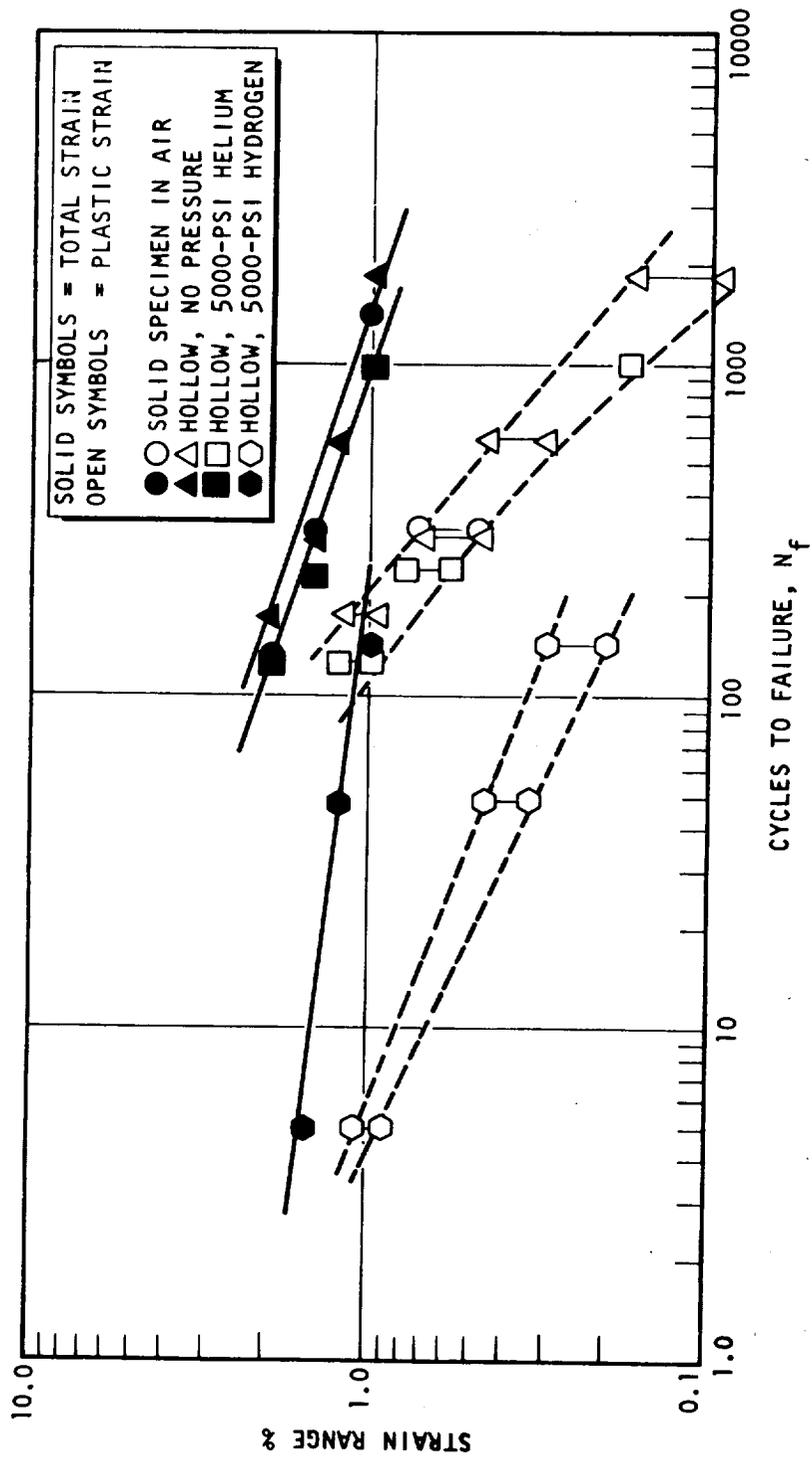
Figure 41 Effect of cyclic strain on fatigue life at 1250° F of annealed Inconel 625 (PWA 1040 Heat Code BLDQ).

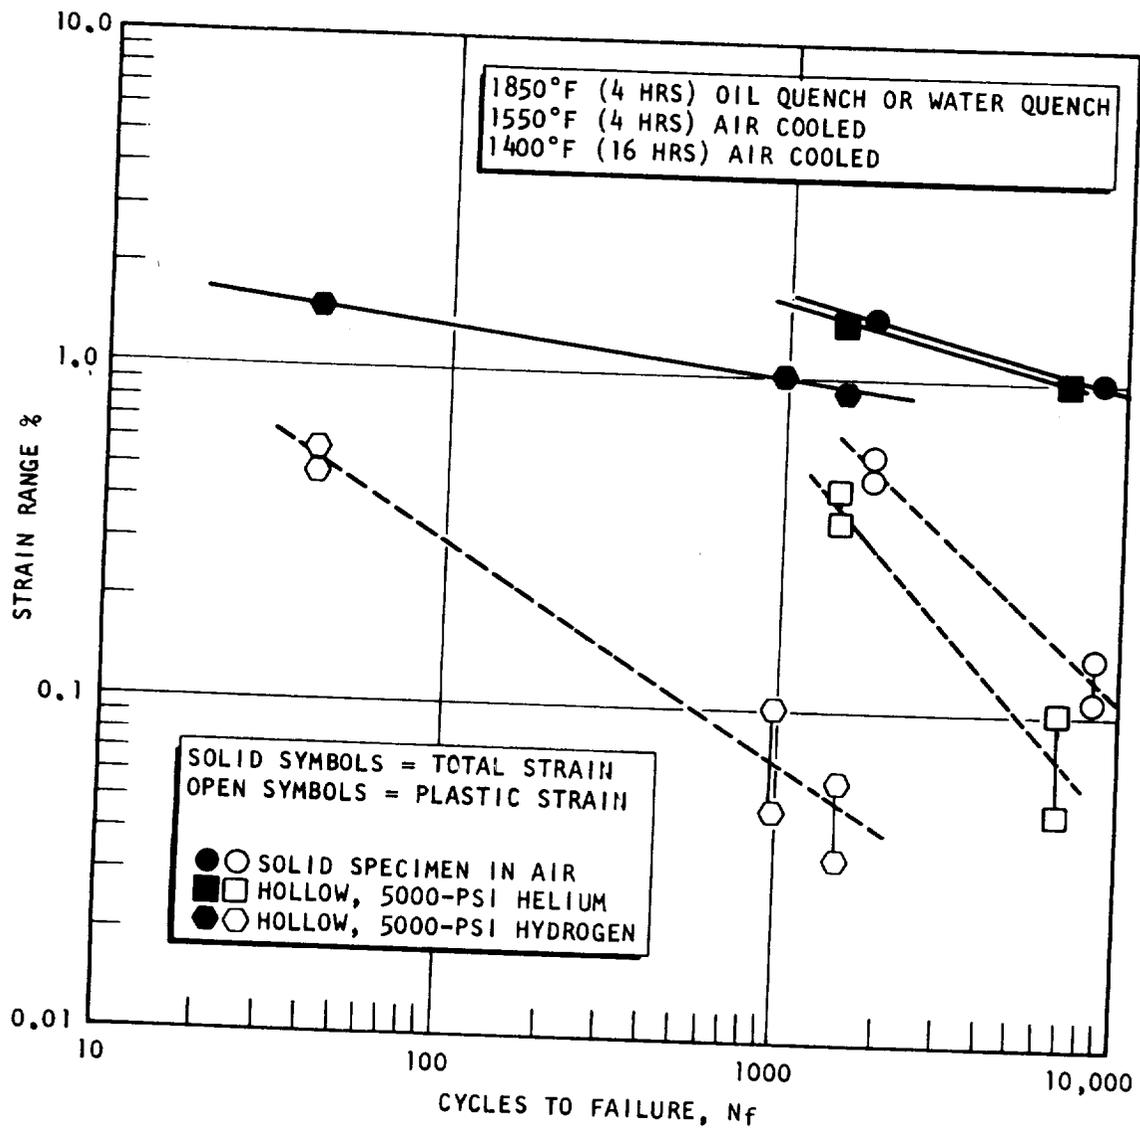
Figure 42. Effect of cyclic strain on fatigue life at 78° F of Waspaloy (PWA 1027 Heat Code LCCS).

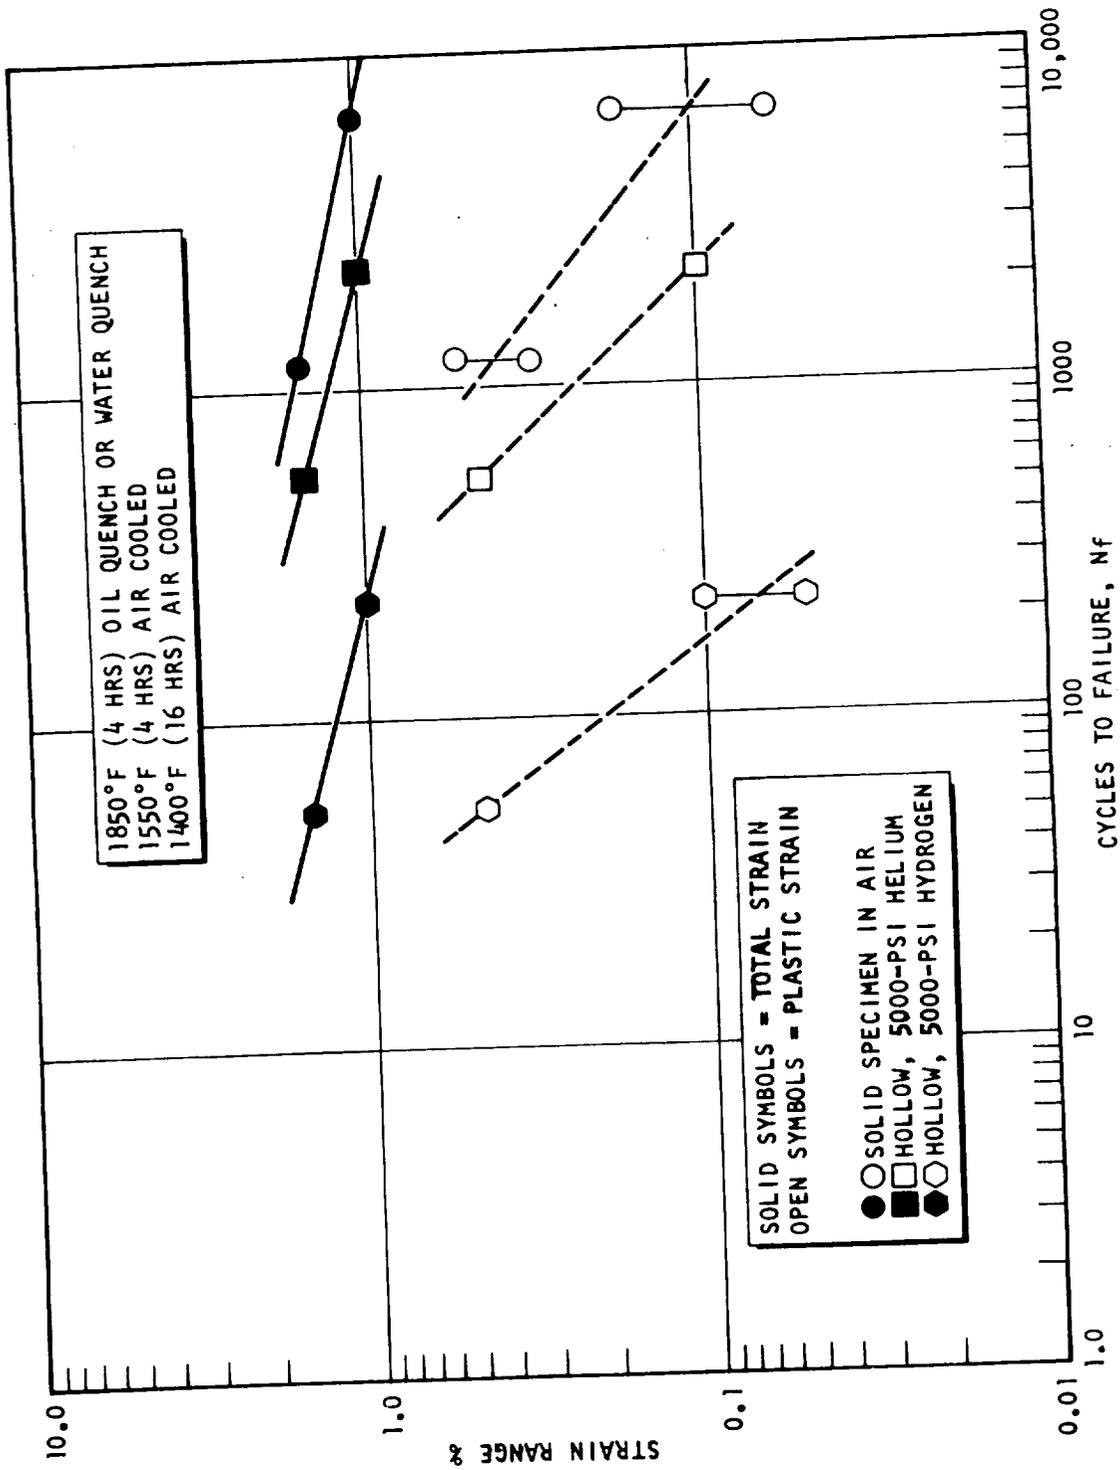
Figure 43. Effect of cyclic strain on fatigue life at 540° F of Waspalloy (FWA 1027 Heat Code LCCS).

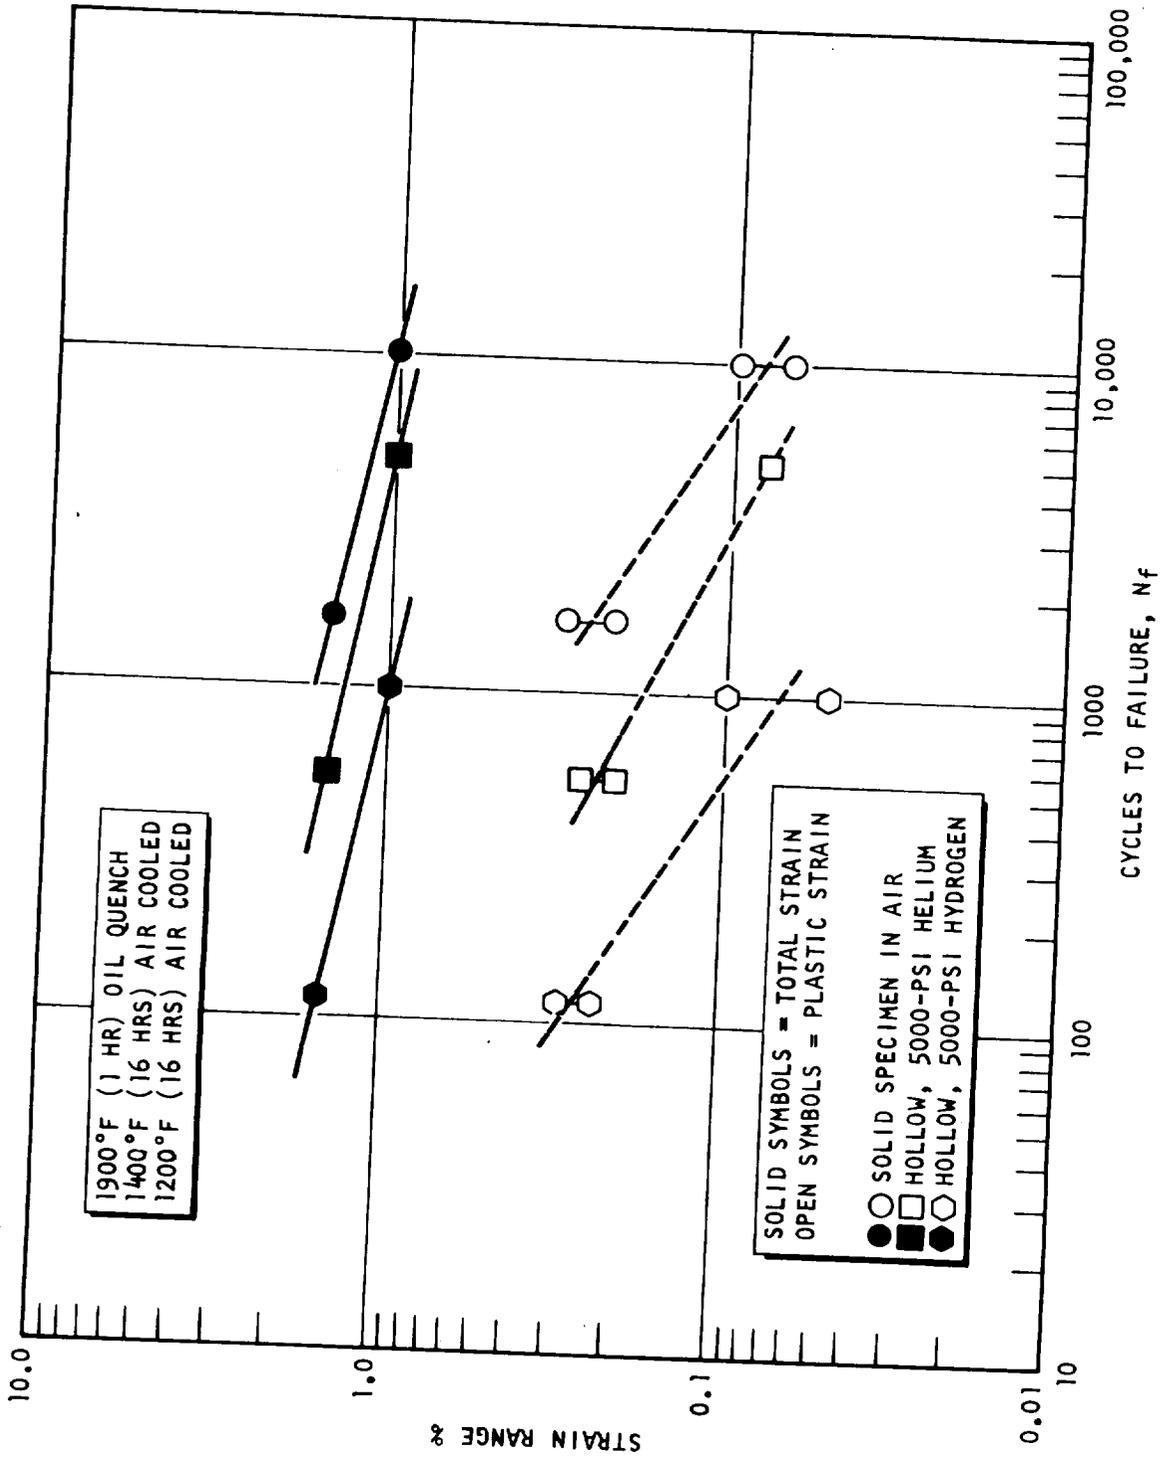
Figure 46. Effect of cyclic strain on fatigue life at 540° F of CG-27 alloy.

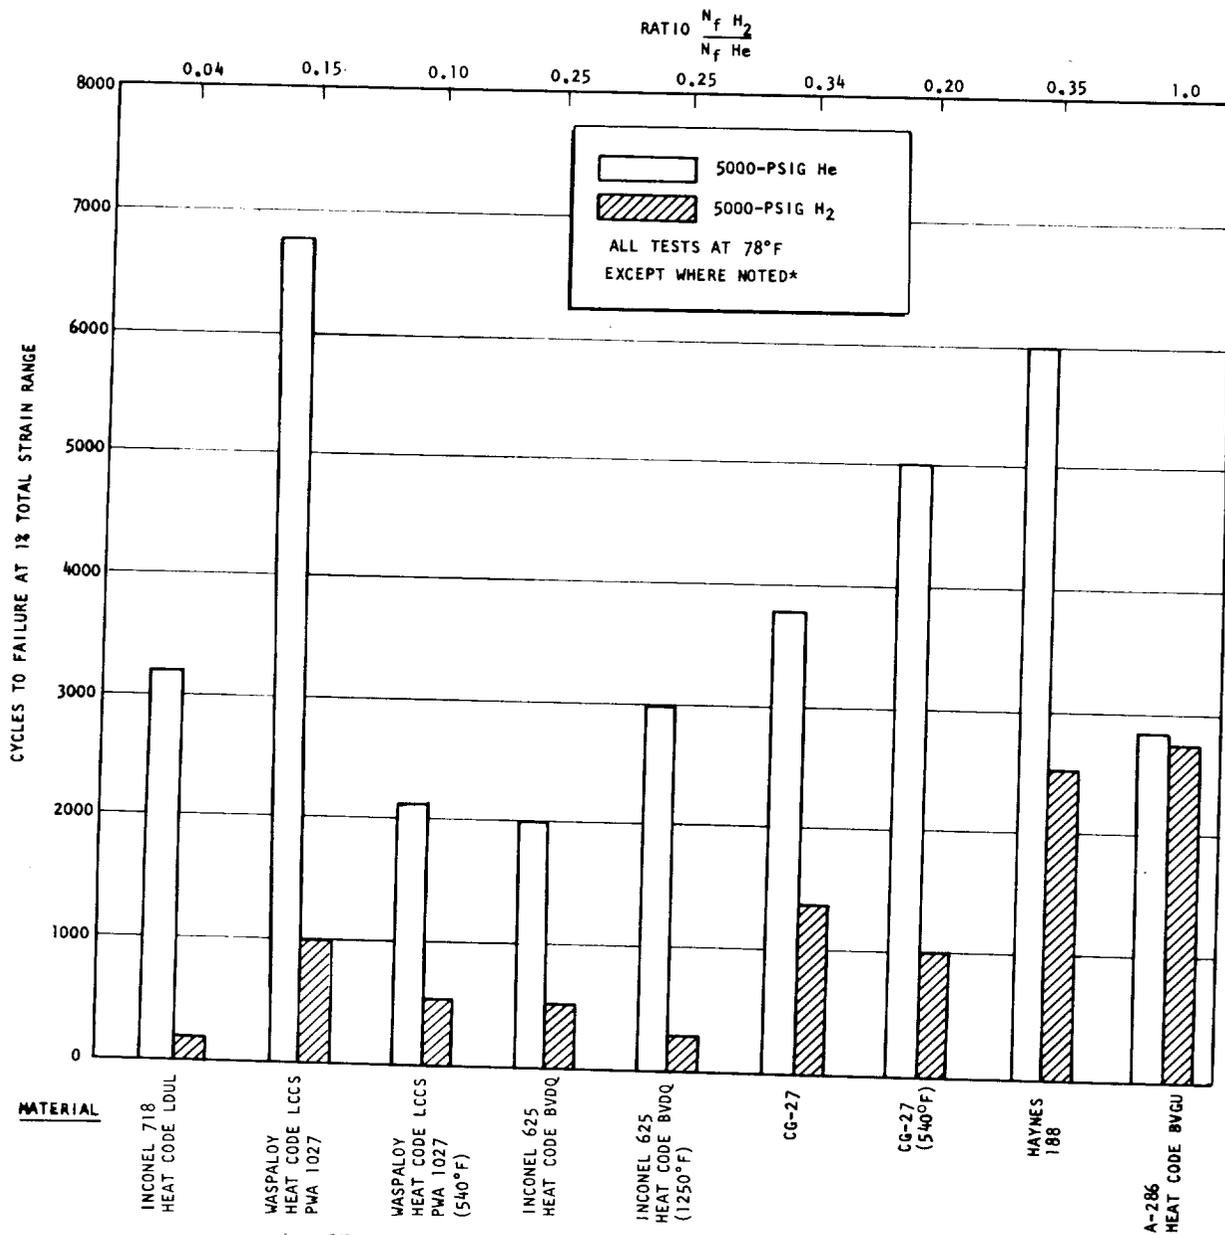
Figure 47. Relative low-cycle fatigue life at 1-percent total strain.

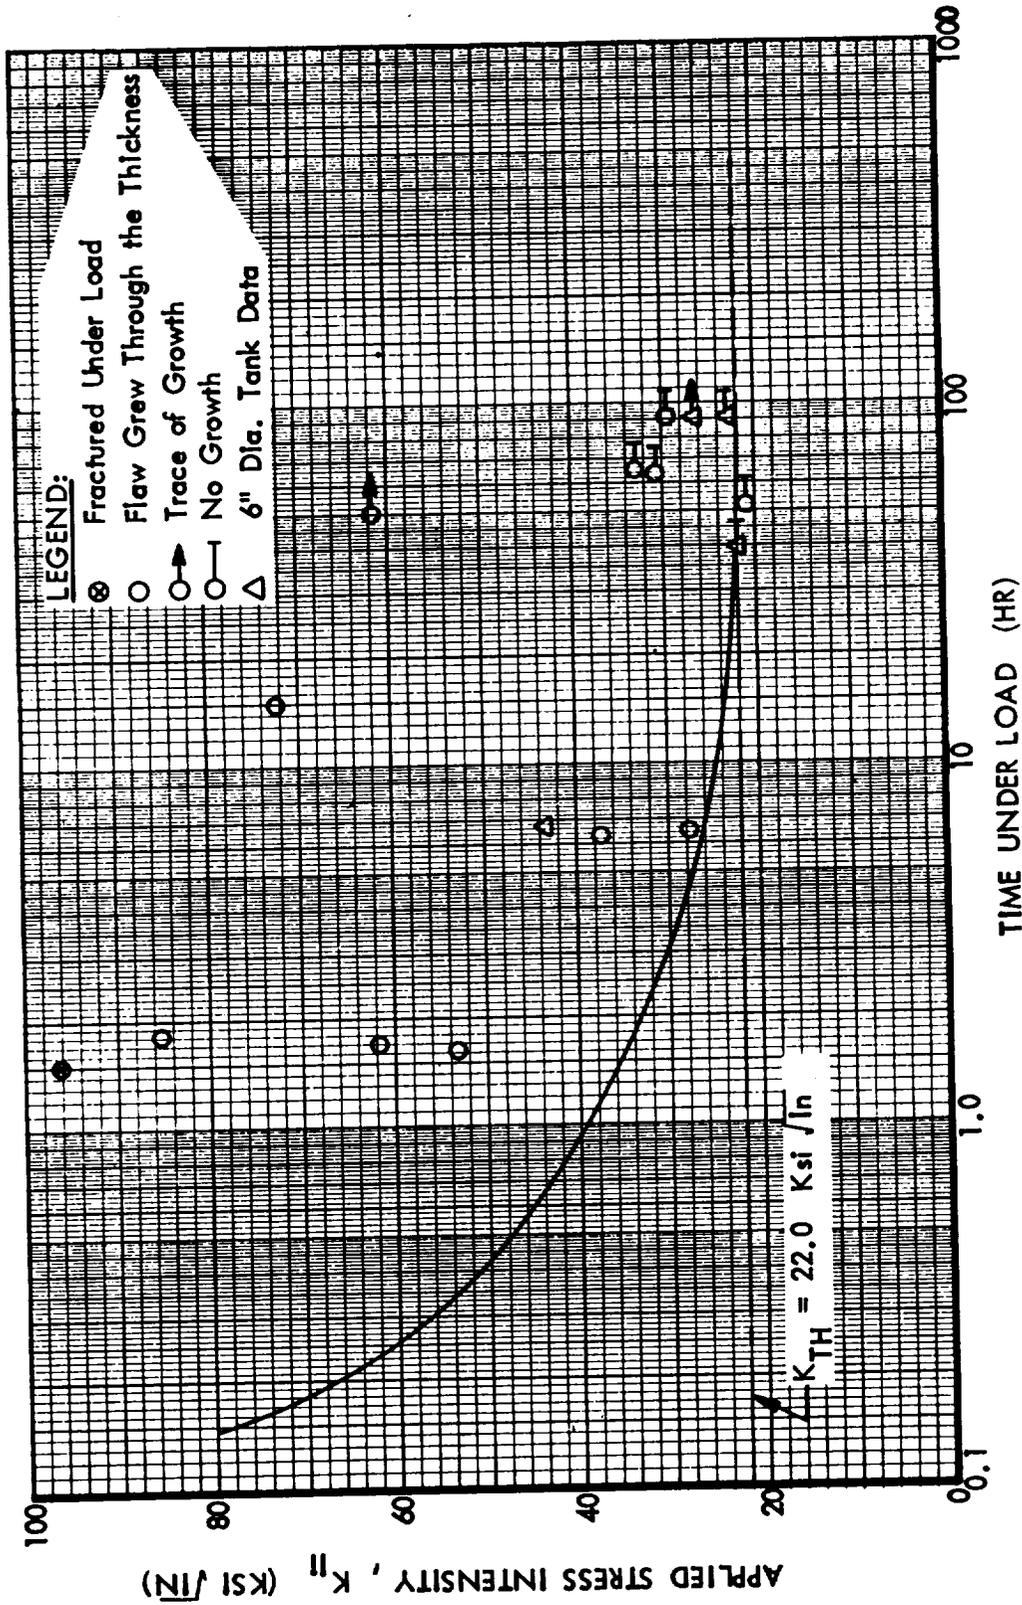
Figure 48. Sustained flaw-growth data for Inconel 718 base metal.

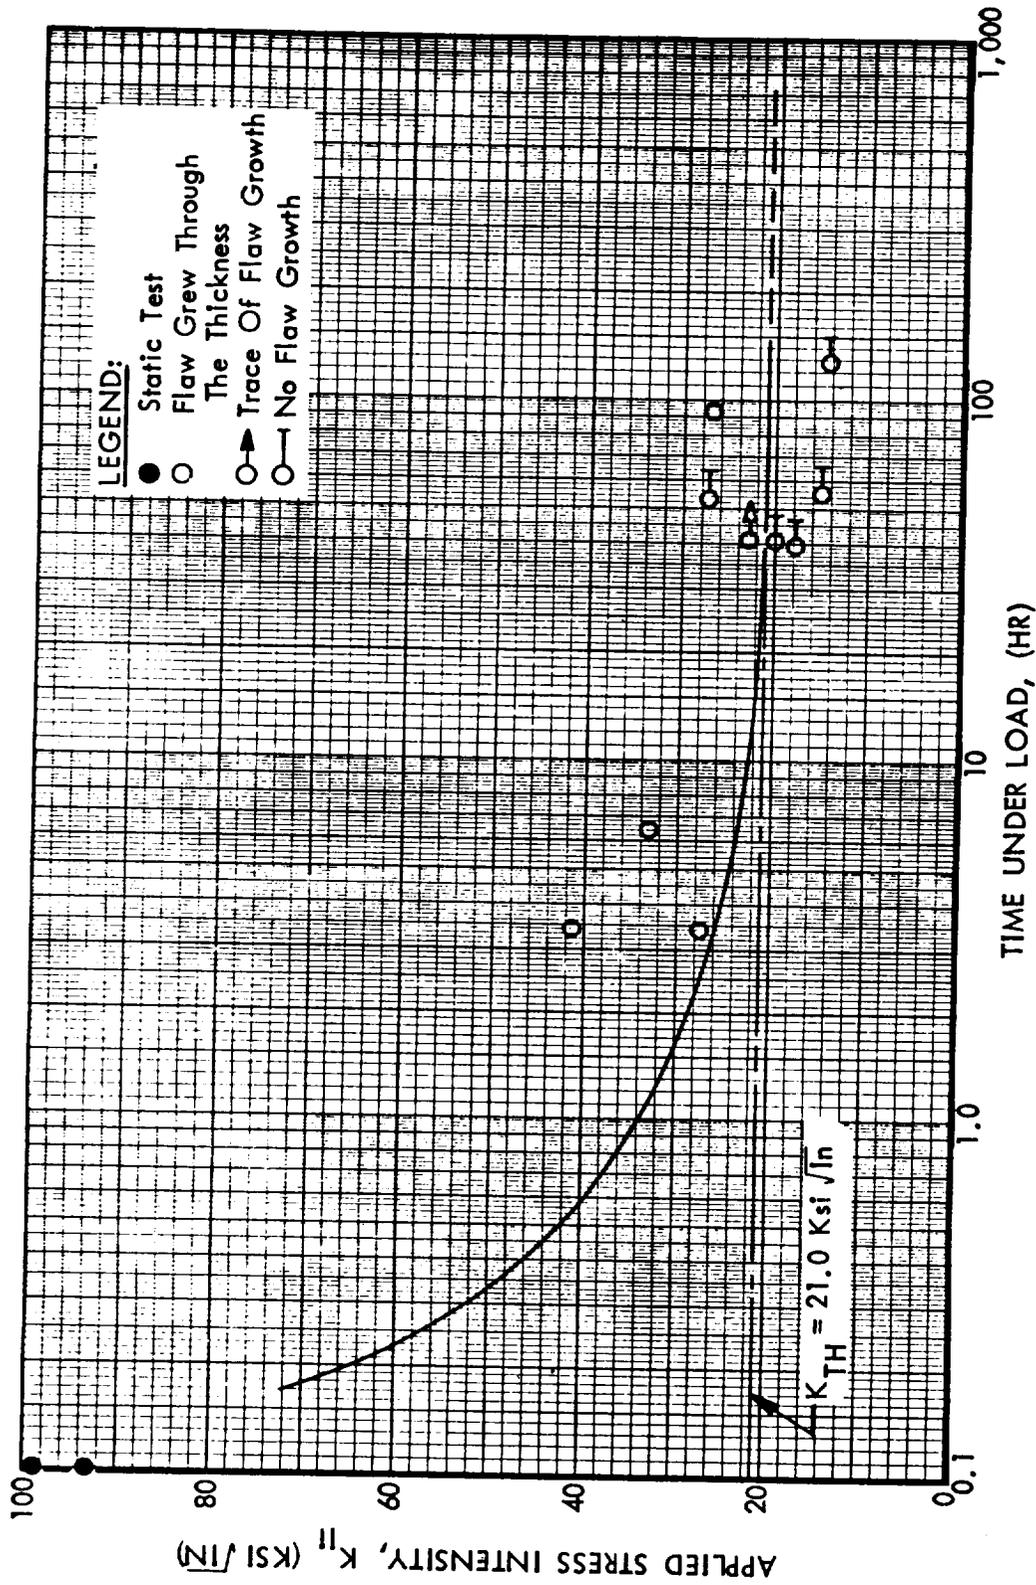
Figure 49. Sustained flaw-growth data for Inconel 718 weldment.

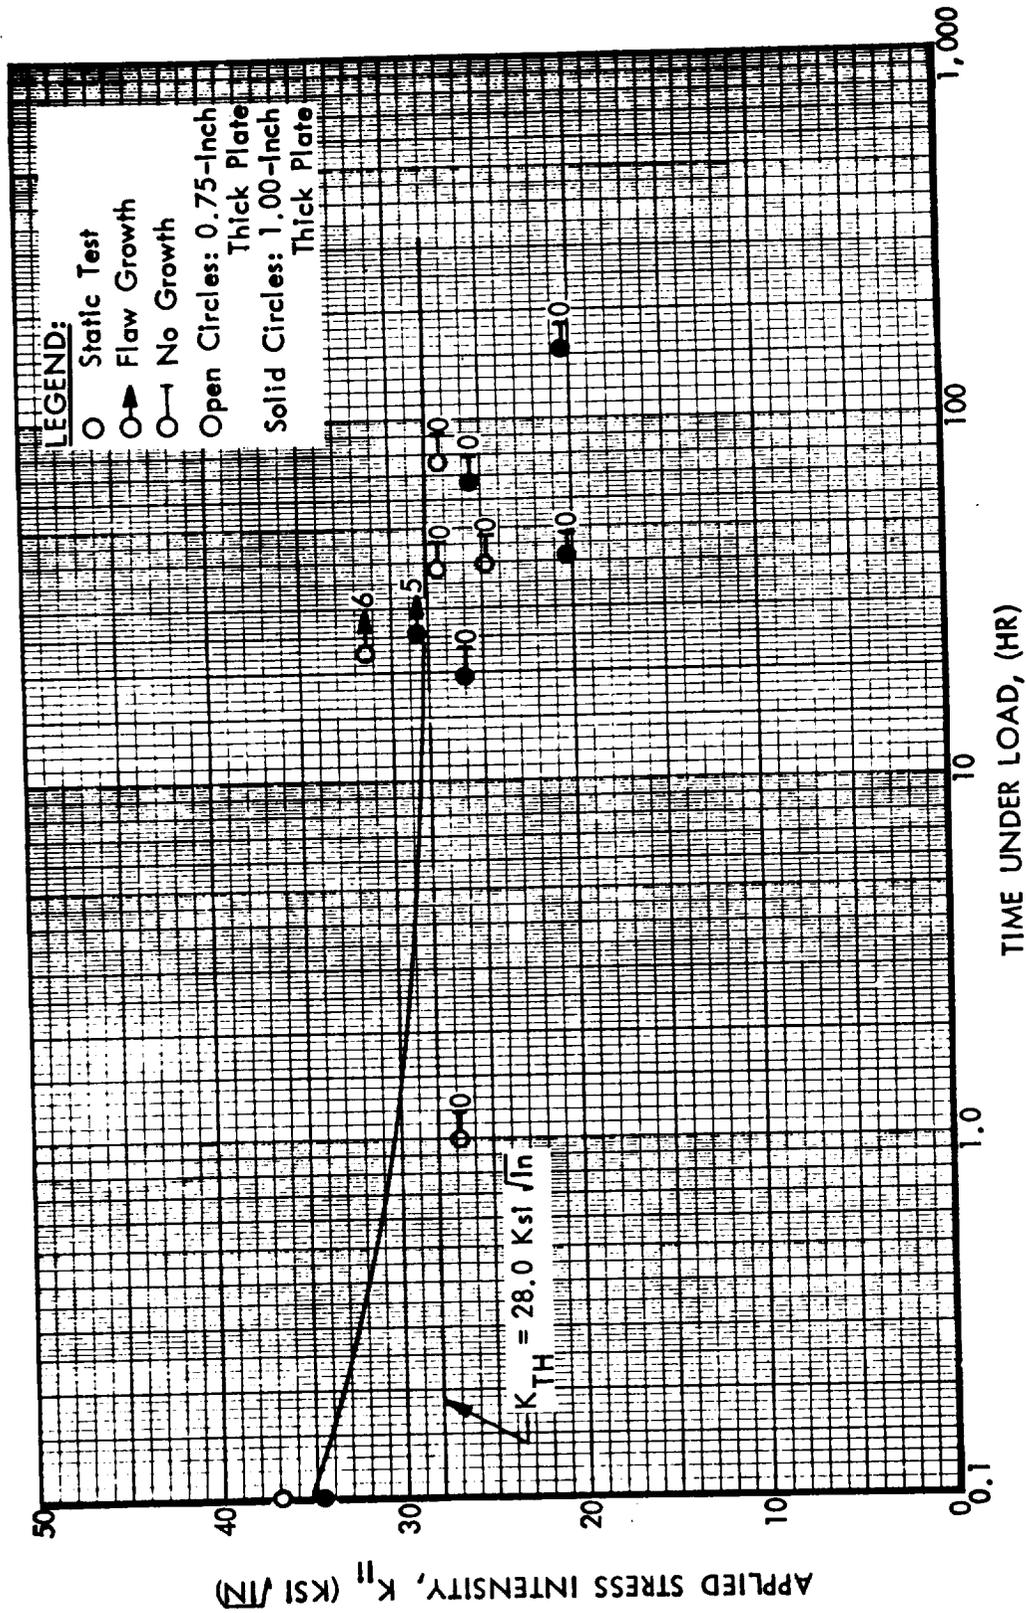
Figure 50. Sustained flaw-growth data for 2219-T6E46 aluminum base metal.

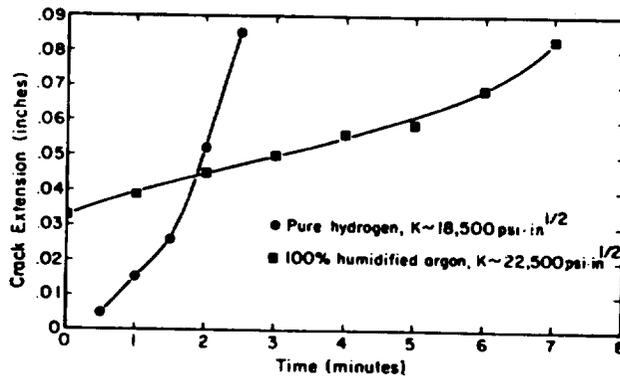
Figure 52. Subcritical crack growth of H-11 steel in molecular hydrogen and humidified argon.

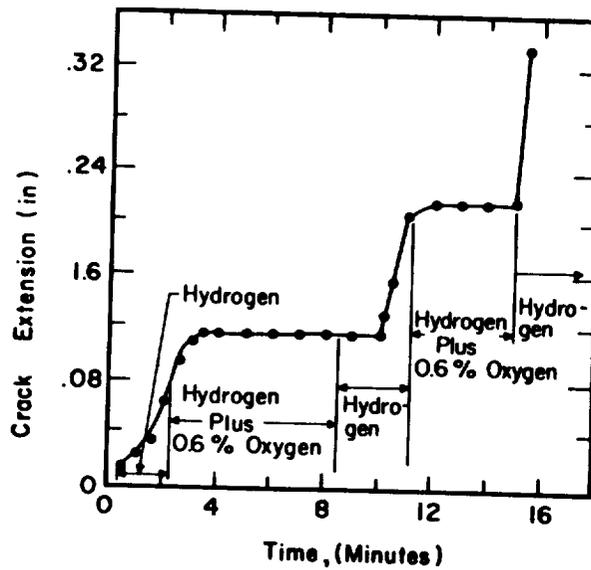
Figure 53. Subcritical crack growth of H-11 steel in hydrogen-oxygen mixtures.

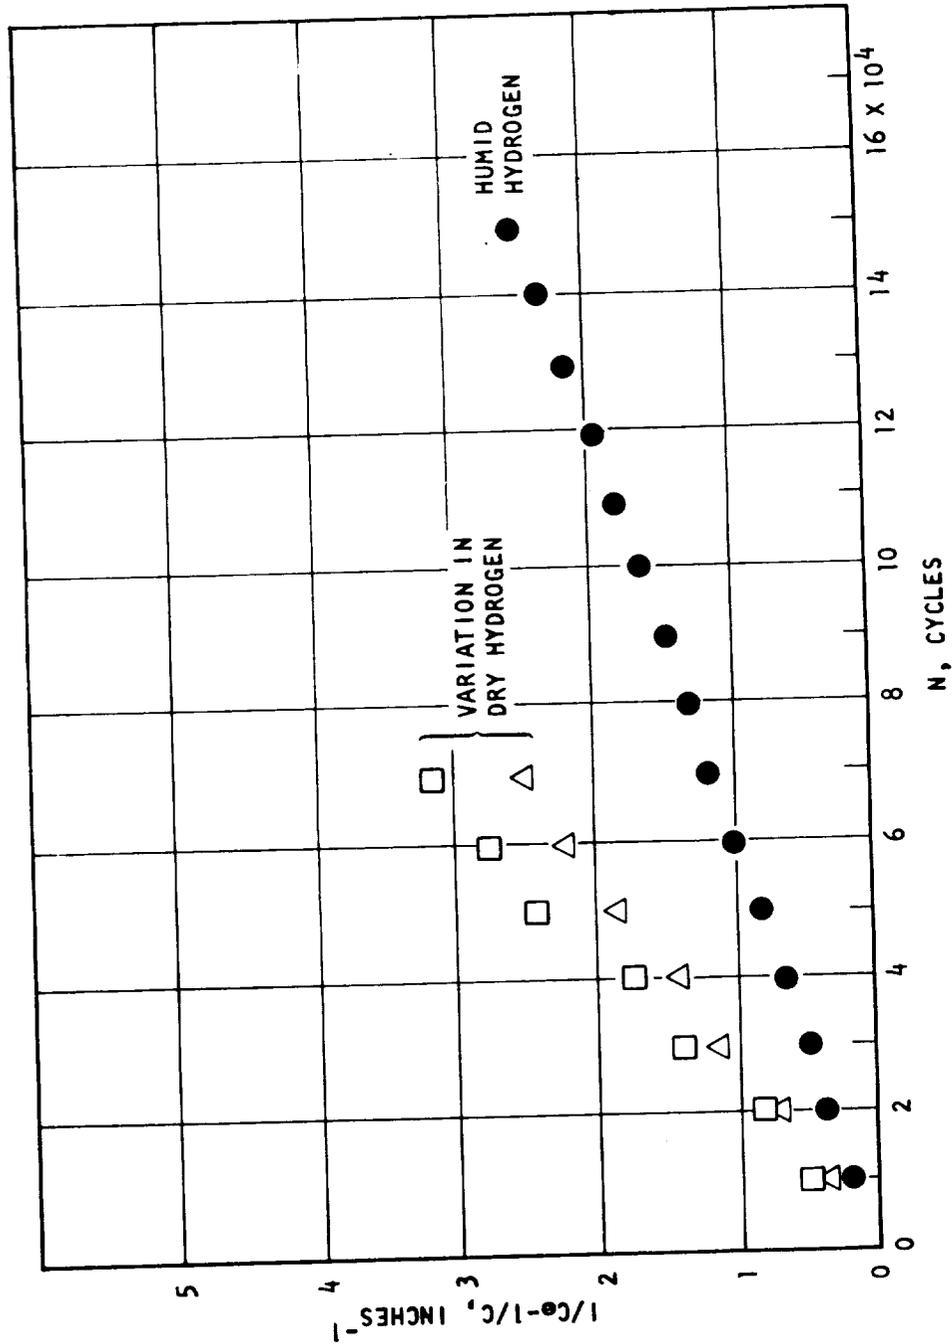
Figure 54. Fatigue-crack growth in 18Ni (250) maraging steel tested in hydrogen.

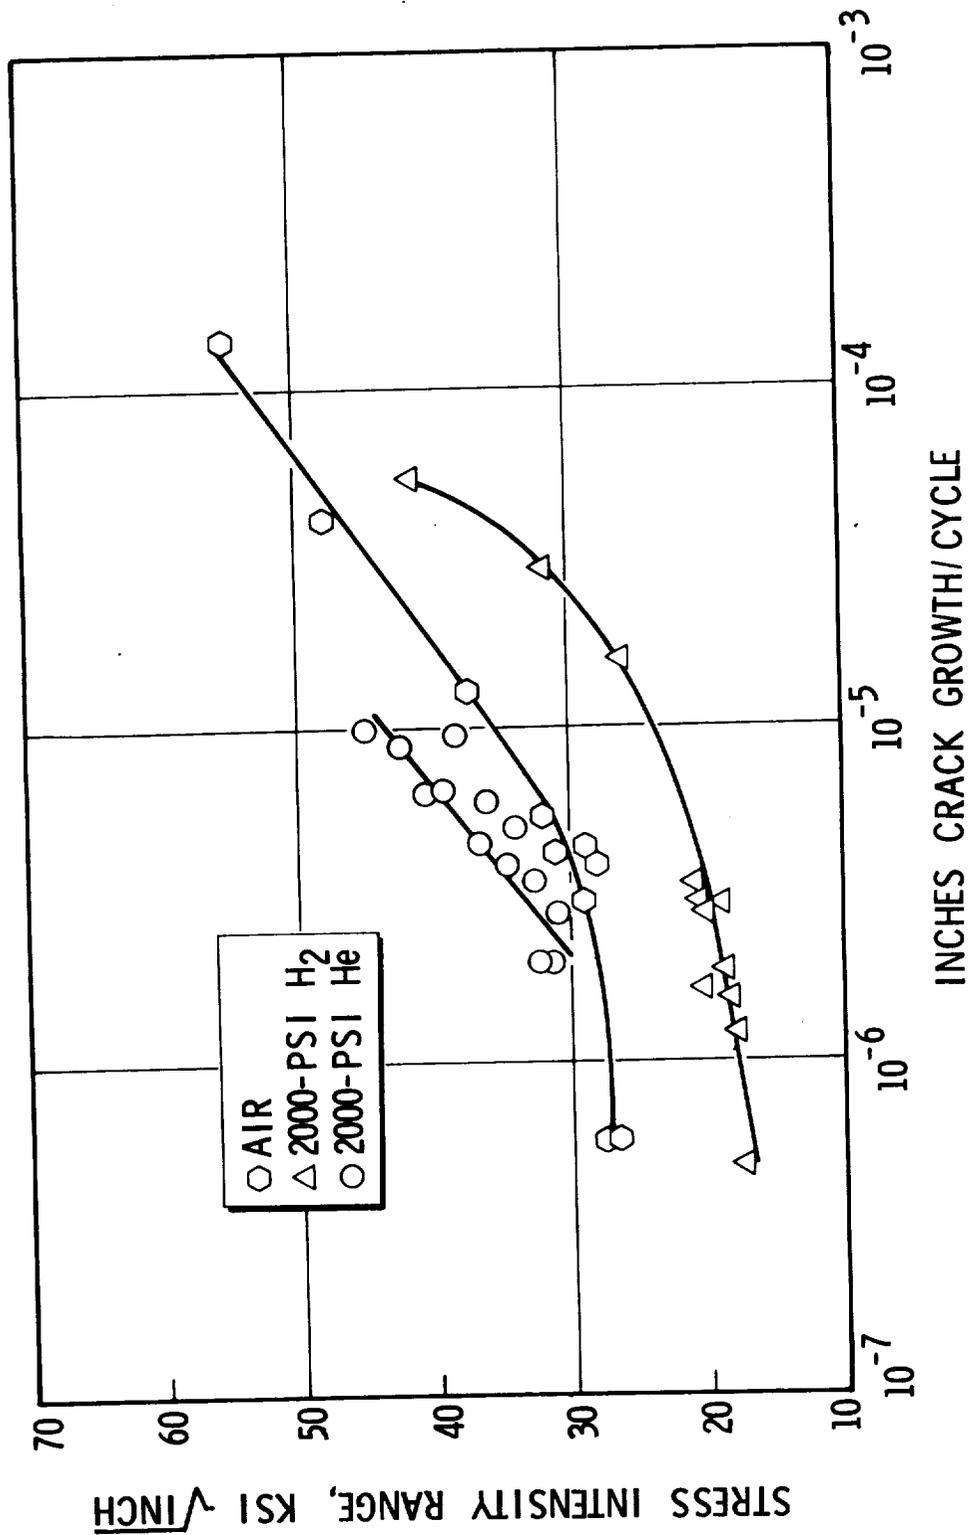
Figure 55. Cyclic crack growth versus stress intensity range during fatigue tests of Inconel 718 at room temperature.
